DAMP INVESTIGATION SURVEY

29 Flockton Crescent, Sheffield. S13 9QR

22 October, 2024.

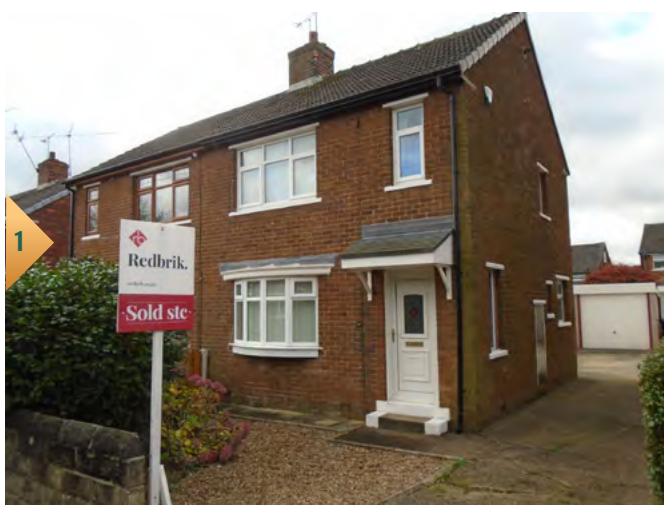
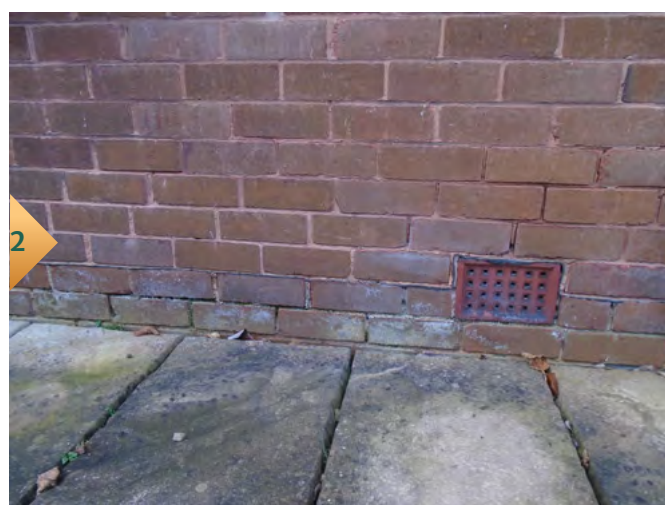
The main walls are constructed from cavity brickwork 275mm thick. The brickwork is generally in reasonable condition, although the pointing at low level has become friable and could be allowing the ingress of dampness. Normally the damp would be restricted to the external skin of brickwork but it appears that post construction cavity wall insulation has been installed which may bridge the cavity and cause internal dampness.

1. Front Elevation
2. Friable pointing to lower section of elevation
3. Friable pointing to lower section of elevation
4. Staining to rain water pipe at high level
5. Algae staining to wall adjacent to downpipe and broken pipe bracket

1. The joints to the brickwork on all 3 elevations should be ground out to a height of 500mm above ground level and pointed in cement mortar to match the existing. This is to include any brickwork fractures.

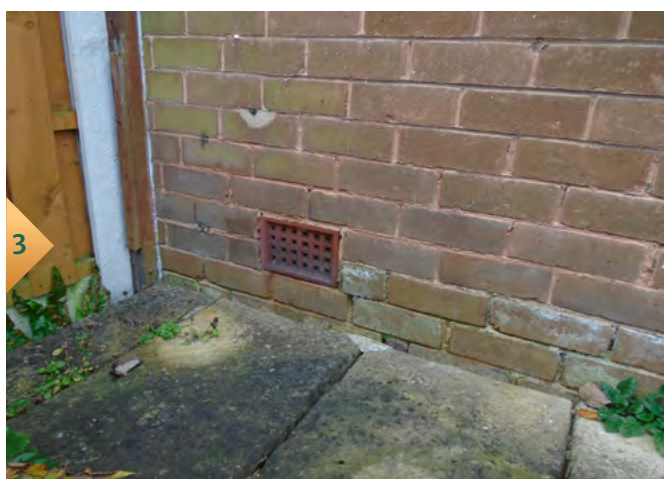
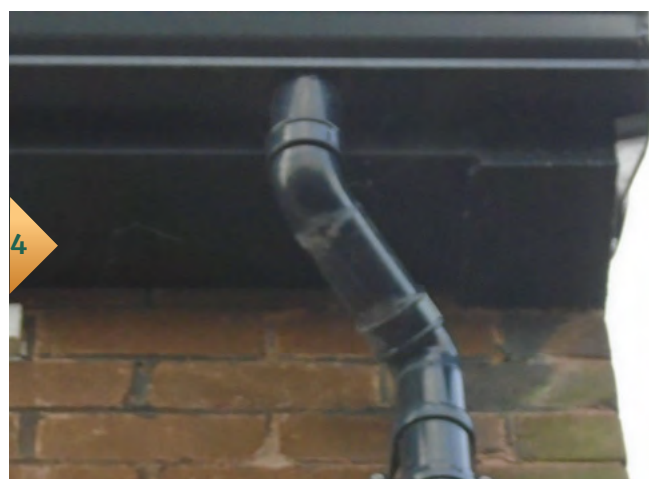
A seamless aluminium gutter runs the full length of the elevation, discharging into a PVCu downpipe at the gable end of the property, which discharges directly on to the paving. The gutter is obviously a recent installation but it is considered that the downpipe may be somewhat older. There is water staining evident around the swan neck at high level and algal staining to the brickwork on the front right hand corner, extending from soffit to ground level. No access was afforded to ascertain whether the downpipe was currently leaking or the staining is of long standing.

2. The front and rear steps should be moved to allow a larger gap between the step and the brickwork.
3. Investigation works should be carried out to ascertain any leaks to the front gutter and downpipe and repaired as necessary. Cleaning of the algal staining to the brickwork in this location is advisable but only for aesthetic purposes.

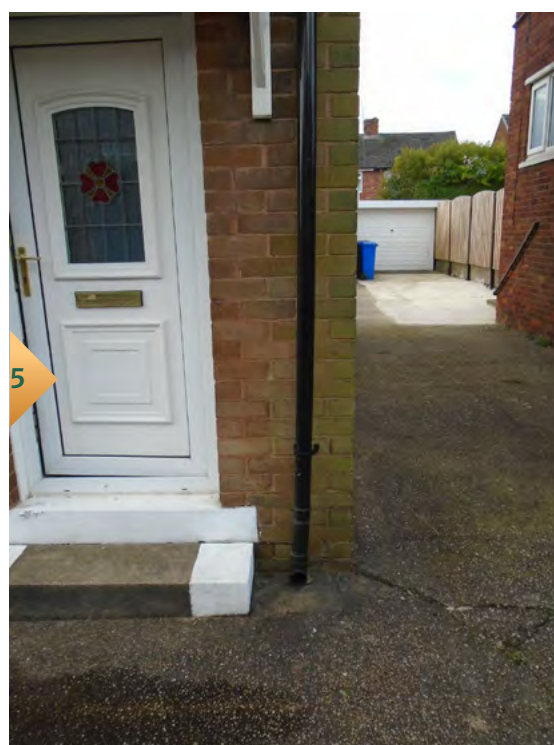
The bottom bracket to the downpipe is broken.

The algal staining to the front elevation is also visible to the gable.

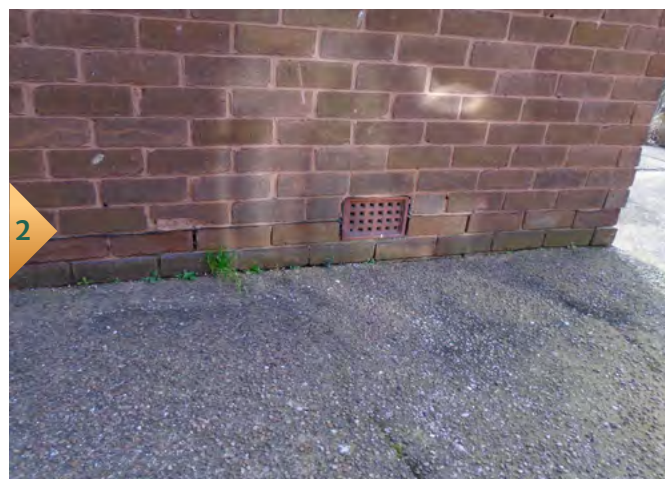
The main walls are constructed from cavity brickwork 275mm thick. The brickwork is generally in reasonable condition, although the pointing at low level has become friable and could be allowing the ingress of dampness. Normally the damp would be restricted to the external skin of brickwork but it appears that post construction cavity wall insulation has been installed which may bridge the cavity and cause internal dampness.

1. Side elevation
2. Friable pointing to lower section of elevation
3. High ground level adjacent to front elevation

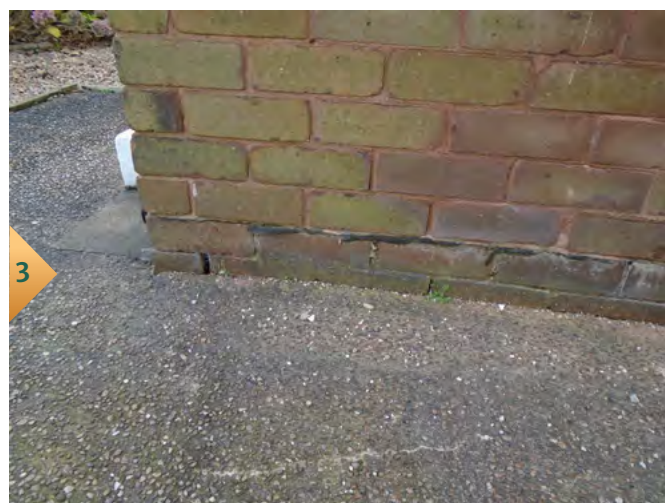
The ground level at the junction with the front elevation is only approximately 100mm below the damp course instead of 150mm minimum specified in Building Regulations.

4. Grind out the concrete paving at the corner of the front elevation and gable 150mm from the brickwork and excavate the sub-base for 100mm; refill the channel with gravel to within 150mm of the damp course.

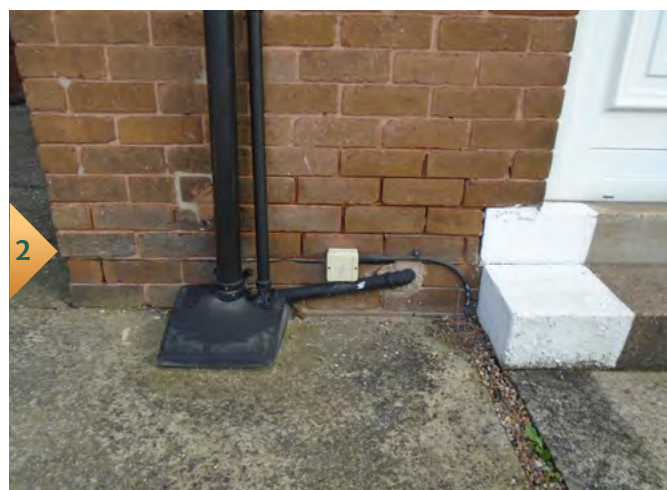
The main walls are constructed from cavity brickwork 275mm thick. The brickwork is generally in reasonable condition, although the pointing at low level has become friable and could be allowing the ingress of dampness. Normally the damp would be restricted to the external skin of brickwork but it appears that post construction cavity wall insulation has been installed which may bridge the cavity and cause internal dampness.

1. Rear Elevation
2. Friable pointing to lower section of elevation
3. Friable pointing and stepped cracking to lower section of elevation

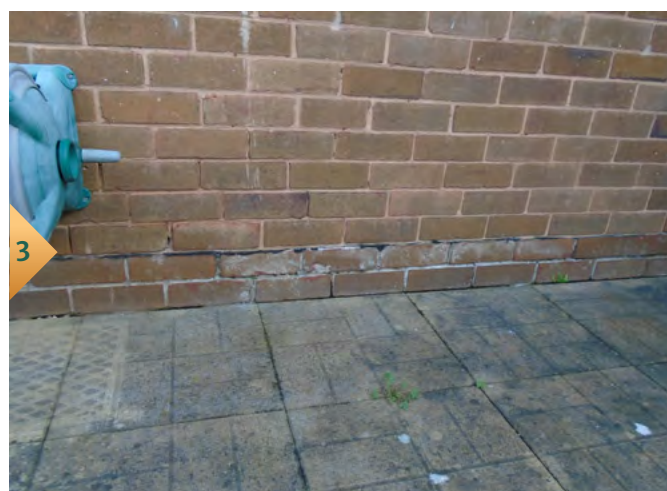
Within the kitchen dining area internally we did find isolated patches of dampness at very low level to the right hand side of the radiator, matching location of the stepped fracture externally, suggesting that dampness is bridging the cavity in this location.

2. There is some cracking to the brickwork on the rear elevation which may be allowing water to penetrate the property.
3. The paving at the corner of the front elevation and gable is less than the recommended 150mm below the damp course.

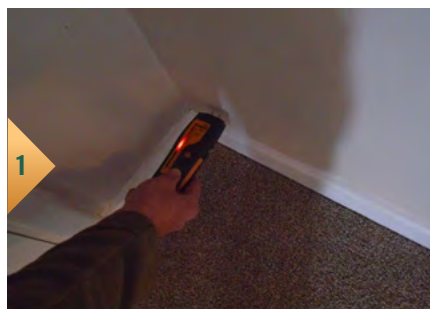
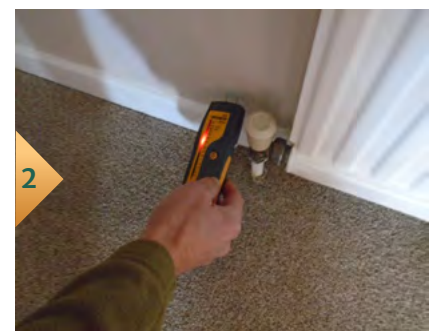
The walls within the lounge are a mixture of plaster on solid walls and plasterboard on studded wall. Generally the walls are in good condition and dry. However, there is evidence of dampness at very low level (just above the skirting board) to the external wall (wall 1). This is considered to be as a result of the friable pointing to the front elevation brickwork, allowing water to penetrate and bridge the cavity at low level.

- Wall 1: Generally green but red to left hand side of radiator.
- Wall 2: Generally green.
- Wall 3: Generally green.
- Wall 4: Generally green but red between the door and wall 1.

1. High meter readings at low level to wall 1 in lounge
2. High meter readings at low level to wall 1 in lounge
3. Satisfactory meter readings at low level to wall 2 in lounge
4. Satisfactory meter readings at low level to wall 3 in lounge

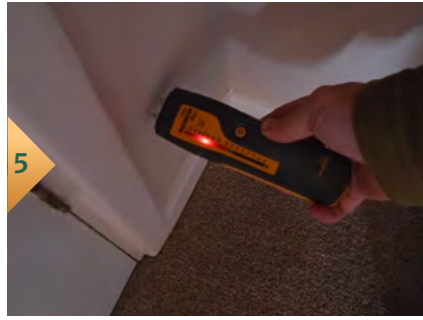
The main area of damp was detected to the left hand side of the radiator adjacent to wall 4.

5. High meter readings to right hand side of door to wall 4 in lounge
6. Satisfactory meter readings at low level to wall 4 in lounge

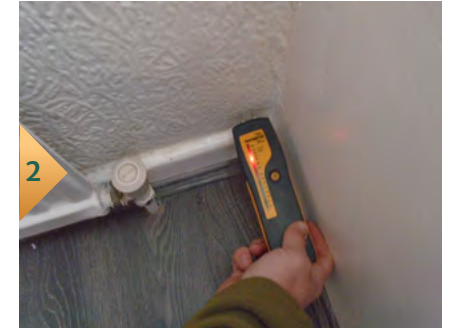
The walls within the kitchen are a mixture of plaster on solid walls and plasterboard on studded wall. Generally the walls are in good condition and dry. However, there is evidence of dampness to the external wall (wall 1) to the right hand side of the radiator. This is considered to be as a result of the friable pointing to the rear elevation brickwork and also a stepped fracture to the brickwork in this location, allowing water to penetrate and bridge the cavity. There is also evidence of elevated meter readings to the left hand side of the external door.

1. Satisfactory meter readings at low level to wall 1 in kitchen
2. High meter readings to right hand side of radiator to wall 1 in kitchen
3. Elevated meter readings to left hand side of external door to wall 1 in kitchen
4. Elevated meter readings to left hand side of arch to wall 3 in kitchen
5. Satisfactory meter readings to left hand side of fireplace to wall 4 in kitchen
6. Elevated meter readings to right hand side of fireplace to wall 4 in kitchen

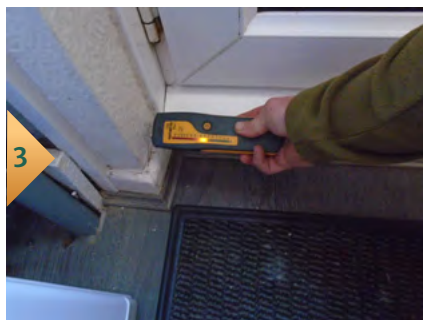
The rear door step has been constructed with a 5mm gap between the step and the wall but is level with the damp course. This may result in water splashing on to the brickwork above the damp course at this point. Internally the left hand side of the rear external door exhibited a high damp meter reading.

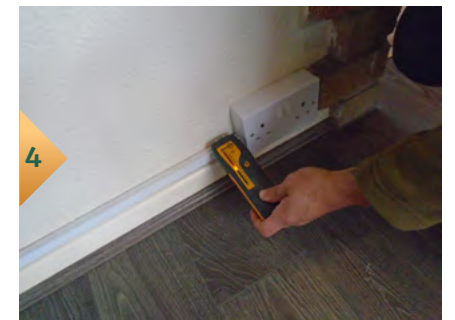
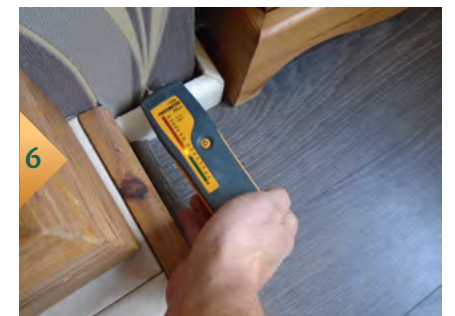
- Wall 1: Generally green but red to right hand side of radiator and left hand external door reveal
- Wall 2: No access due to kitchen units.
- Wall 3: Generally green but elevated (amber) readings at low level either side of archway.
- Wall 4: Generally green but elevated (amber) to right hand side of fireplace.

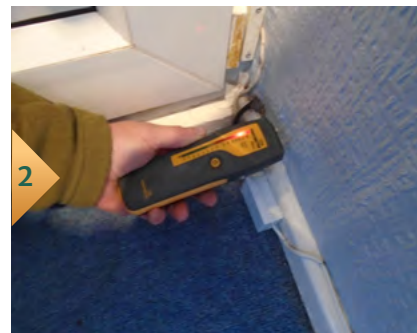
The walls within the lounge are a mixture of plaster on solid walls and plasterboard on stud wall. Generally the walls are in good condition and dry. However, there is evidence of dampness at very low level (just above the skirting board) to the lounge wall (wall 2) between the external wall and the lounge door.

1. Satisfactory meter readings to left hand side of external door to wall 1 in hallway
2. High meter readings to left hand side of lounge door to wall 2 in hallway

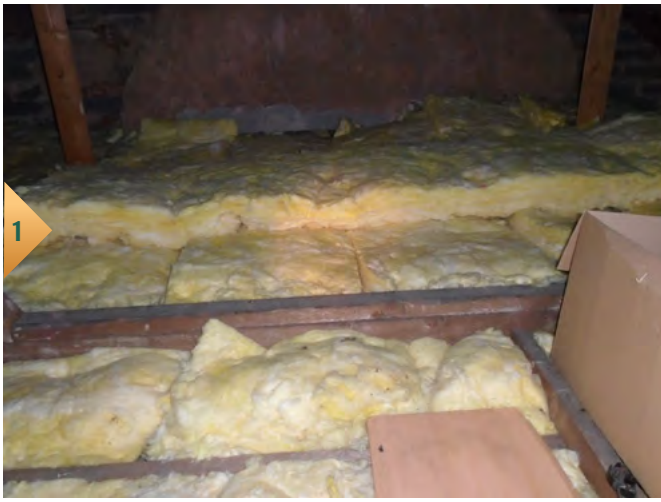
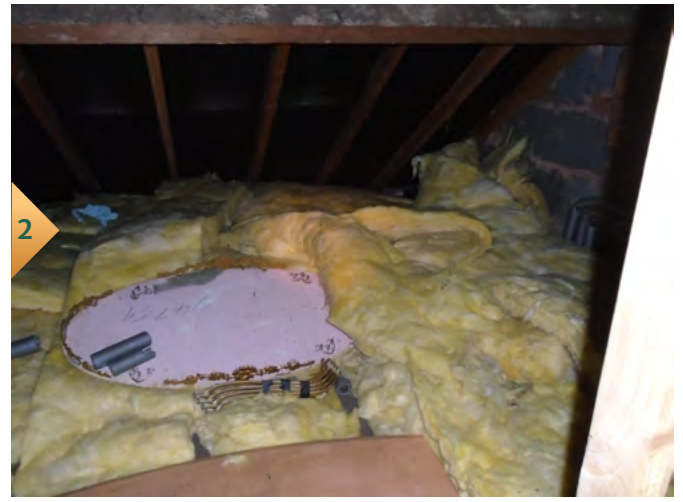
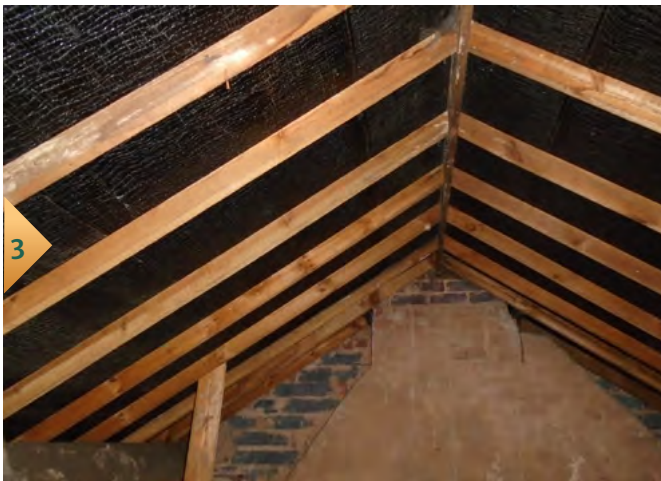
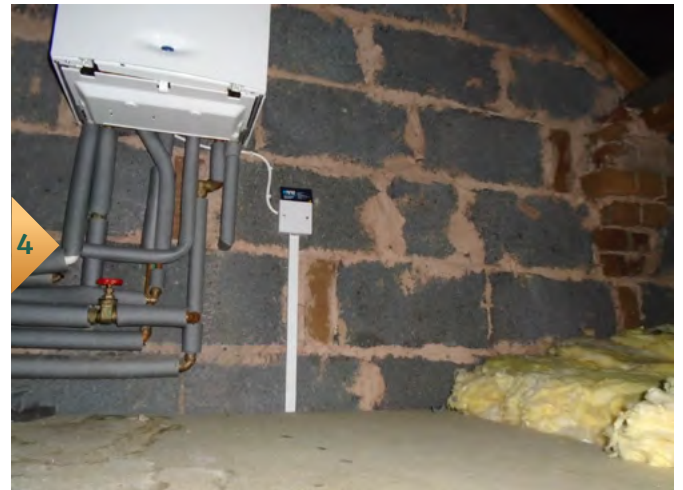
Mineral fibre insulation is laid across the ceiling joists and is random in thickness, possibly due to lifting during other works. The recommended thickness of insulation is 300mm and this is achieved in some places but not in others. It would also appear that the insulation has been tightly packed into the eaves spaces, thus limiting to natural ventilation in the roof space. The insulation requires resitting, topping up where necessary and removing from the eaves spaces. It was noted that there are no vents in either the front and rear soffits, the gable end or the roof tiles. It is strongly recommended that either soffit vents or vented roof tiles are installed to prevent condensation in the roof space.

1. General view of roof space
2. General view of roof space
3. General view of roof space
4. General view of roof space

8. There is no natural ventilation to the roof space.

7. Relay insulation within the roof space to ensure 300mm overall coverage, topping up where necessary. Ensure the insulation is not tightly packed into the eaves to allow natural ventilation. It is also recommended that either soffit vents or roof tile vents are fitted.
