# DAMP INVESTIGATION SURVEY

5a Green Lane, Belper. DE56 1BY

25 September 2025

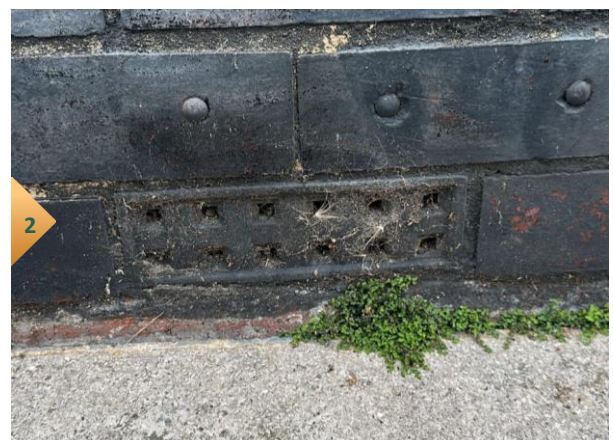
The render generally appears in reasonable condition. The painted brickwork is showing signs of flaking and algal growth. Within the brickwork there is 1 no 150 x 75mm air brick ventilating the sub floor space. This is insufficient in both size and number; minimum requirements are for 150 x 225mm air bricks at 2 metres intervals.

1. Front elevation
2. Undersized air brick and pressurised damp course
3. Front porch

8. Trickle vents are required to the windows. If this is not possible, then installation of air bricks should be considered.
9. Installation of sufficient air bricks to provide air flow to the timber flooring.

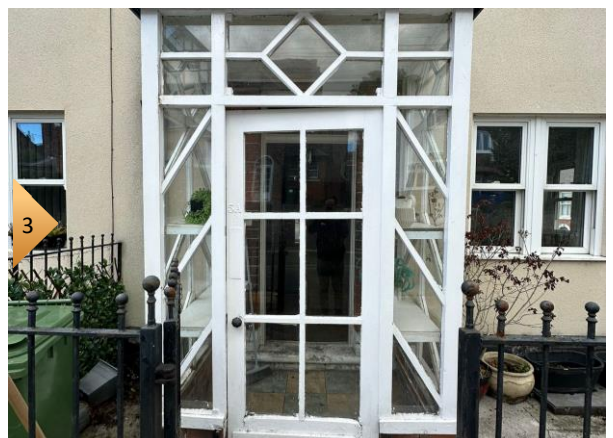
There is a small porch attached to the front elevation and this is completely dilapidated and not fit for purpose. It requires demolishing.

5. The gutters require checking by a qualified roofer and possibly redesigning to prevent gutter overflow.
6. The front porch requires demolition.
7. The extractor fan requires an external grill to be fitted.

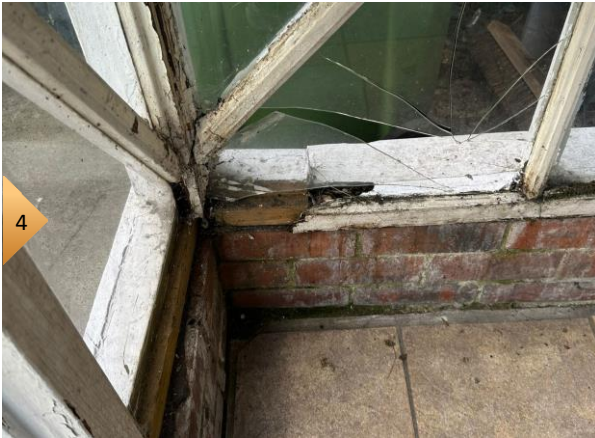
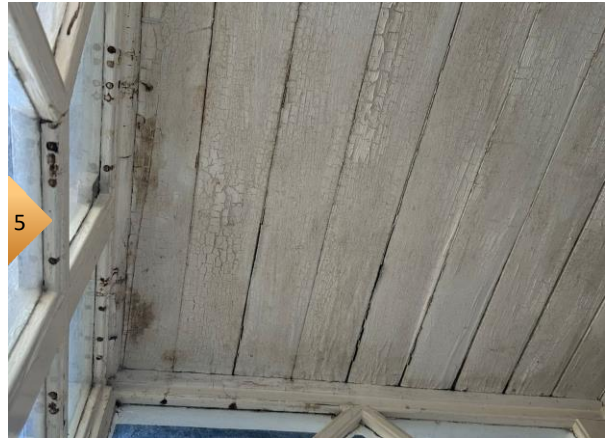
4. Dilapidated Porch
5. Dilapidated Porch
6. Water staining behind downpipe
7. Water staining behind downpipe

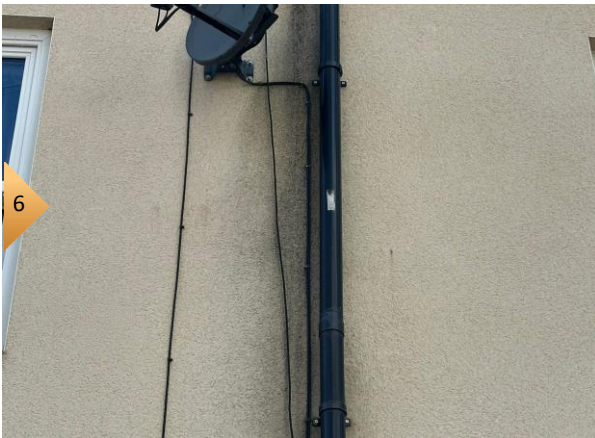
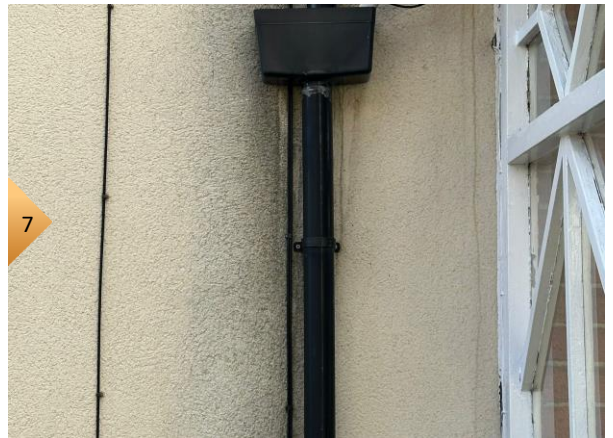
Plastic gutters and downpipes. There were signs of water staining adjacent to the downpipe..

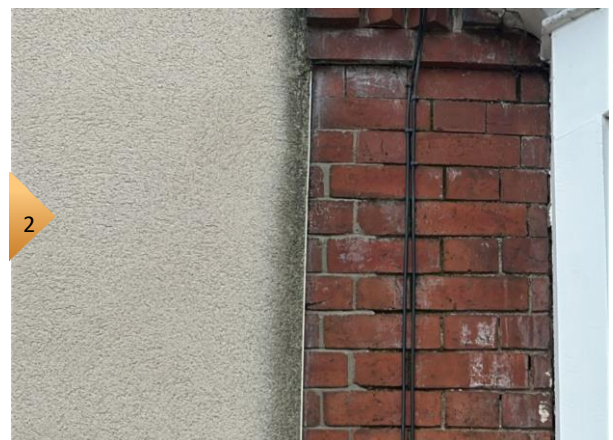
Plastic gutters discharging on to the roof of the neighbouring property. This is an unsatisfactory arrangement and it would appear the gutter below is overflowing on to the brickwork and render. Further investigation is required by a qualified roofer to determine the direction and rate of flow of the gutters.

1. Right hand side elevation
2. Water staining to high level brickwork/render
3. Low level brickwork

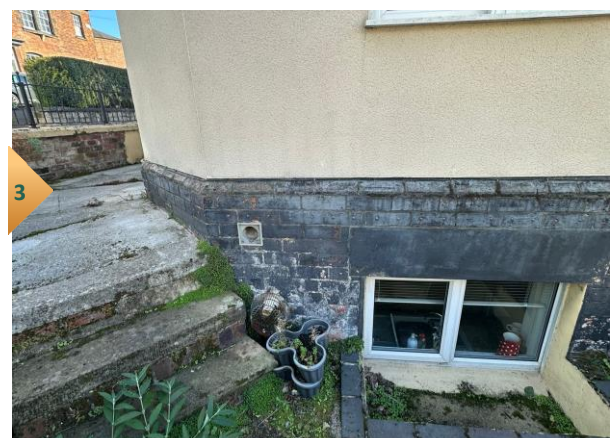
The render generally appears in reasonable condition. The painted brickwork is showing signs of flaking and algal growth.

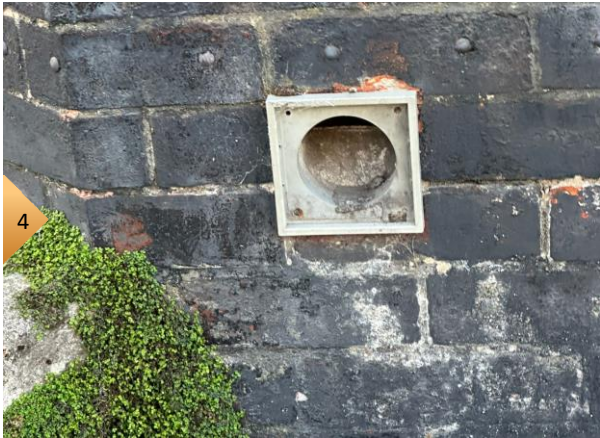
4. Missing cover to extractor fan in bathroom.
5. No trickle vents to window

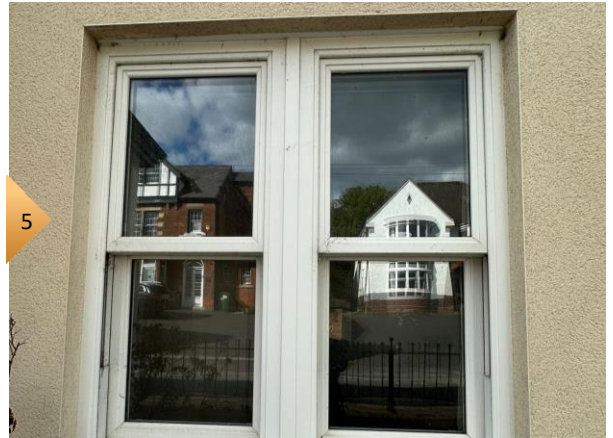
The windows are PVCu sliding sash windows but there are no trickle vents fitted, preventing adequate ventilation to the property.

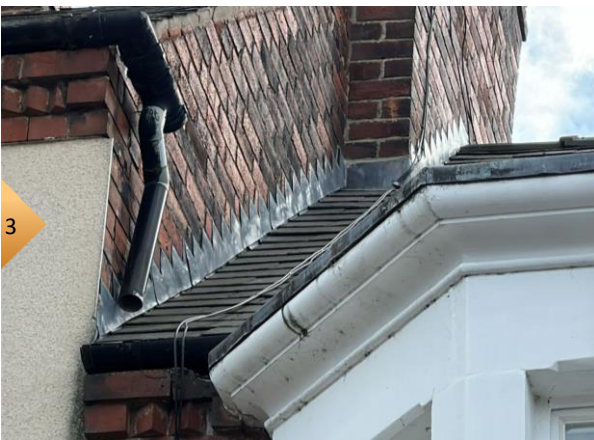
1. General view of roof
2. Flashing to chimneys
3. Gutter discharging on to neighbouring property roof
4. Water staining to render/brickwork

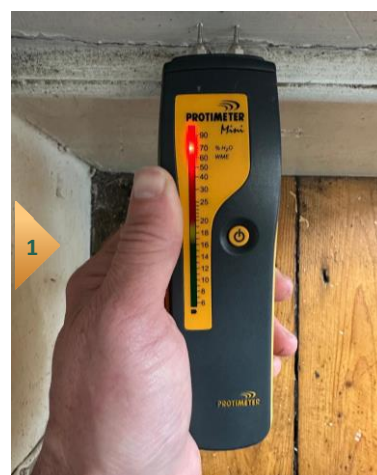
The walls are of masonry construction with a plaster finish and emulsion painted. The external wall (Wall 1) is showing readings in the red zone at low level to both sides of the door, reducing to green at 1 metre above floor level, indicating rising damp. These readings also extend along walls 2 and 4, reducing to green adjacent the staircase

1. Wall 1, low level left hand side of door

2. Regarding the rising and penetrating damp issue on the ground floor, the external walls and affected internal walls require plaster removing to 1 metre above floor level and drilling and injecting with a damp proofing cream. Then a damp proof membrane should be mechanically fixed to the walls. Following this treatment, it is recommended that all the walls be finished with 12.5mm plasterboard with a skimmed finish

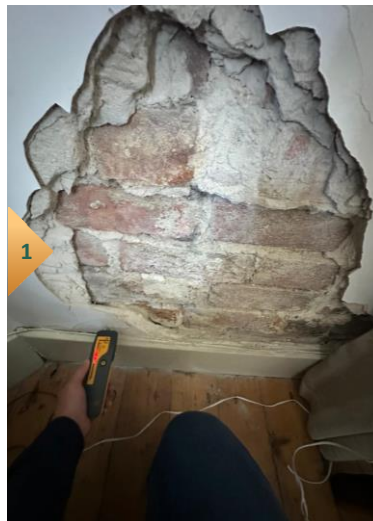
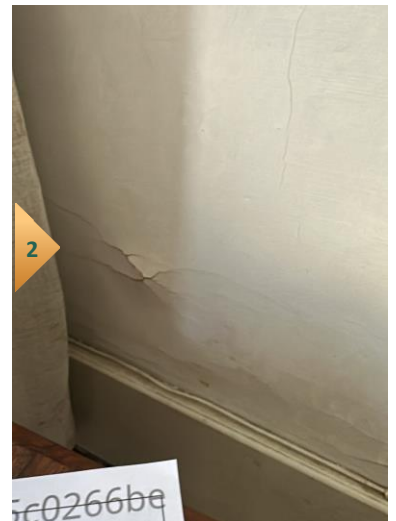
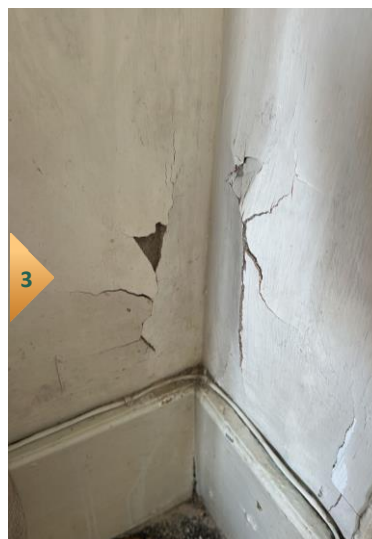
The walls are of masonry construction with a plaster finish and emulsion painted. Below the left hand side of wall 1 (Front Window) there is a large area of blown plaster, revealing the brickwork below. On the surface of the brickwork there is evidence of salt contamination; the meter reading was 30%. The remaining area of wall at low level exhibits flaking of paintwork. A reading of 60% was recorded under the window, reducing to 40% to the left hand side.

1. Wall 1 Blown plaster below left hand side of front window
2. Wall 1 below centre of front window
3. Wall 1 below right hand side of front window
4. Blocked flue

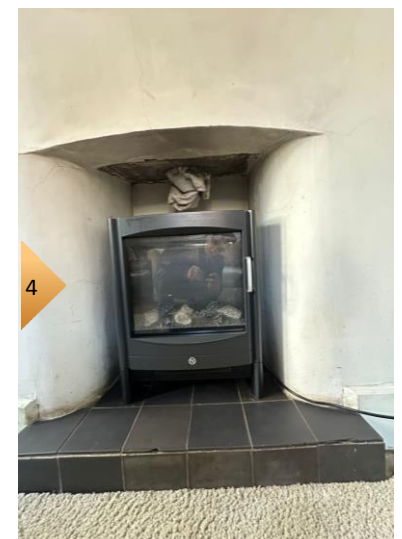
In addition, the original fireplace has been removed and an electric fire installed. The chimney opening has been blocked up with a towel, thus reducing the ventilation to the room

10. The flue to the living room requires venting correctly

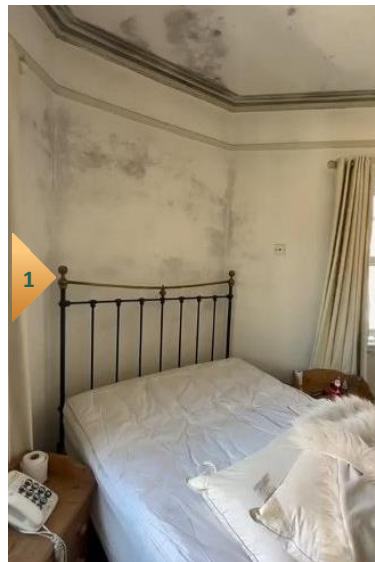
The walls are of masonry construction with a plaster finish and emulsion painted. Generally the walls are in reasonable condition, but, due to the lack of ventilation in the room (no trickle vents to windows), there is widespread condensation staining to the ceiling and external walls.

1. Condensation staining to ceiling and external walls

3. Within the front bedroom, the mould to the walls and ceiling should be chemically removed. The external walls should then be studded and finished with insulated plasterboard to increase the thermal properties and reduce the risk of condensation. It is also recommended that a Positive Input Ventilation (PIV) unit be installed to improve air circulation.

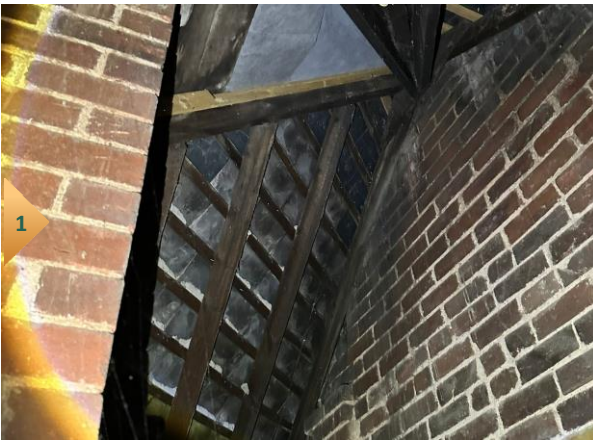
The roof space was found to be in reasonable condition and dry. There were signs of historic water staining around the chimney but also signs of repair in this area. There were several old birds' nests and wasp nests within the roof space, which will require removal.

1. Historic water staining around chimney
2. No Insulation
3. No insulation
4. Birds' nests

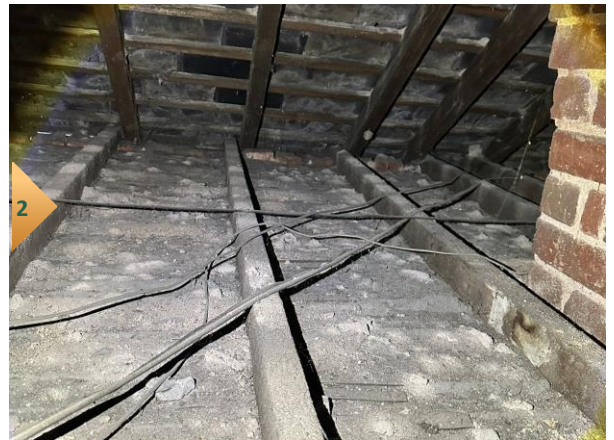
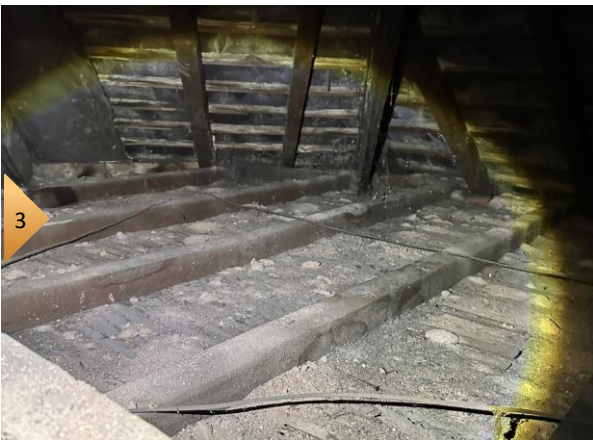
It was also noted that there is no insulation within the roof space. A minimum of 350mm of insulation is required to meet current building regulations. This will also help prevent condensation in the upper floor areas.

4. The bird's nests and wasp nests within the roof space should be cleared. Then a minimum of 350mm of insulation be installed between the joists. It is also recommended that a qualified roofer check the roof to ascertain if entry points for birds are still extant.

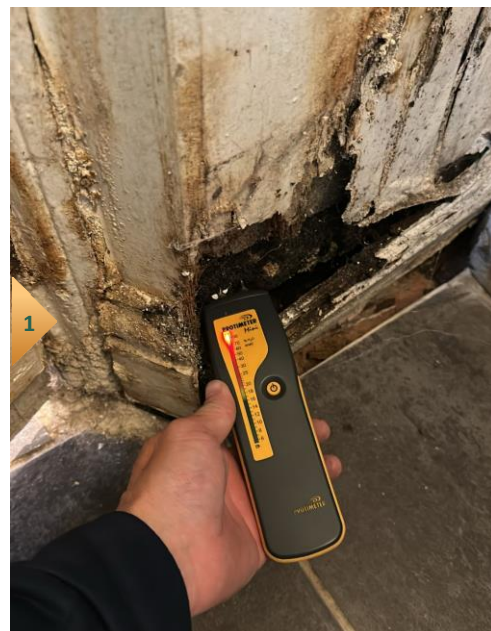
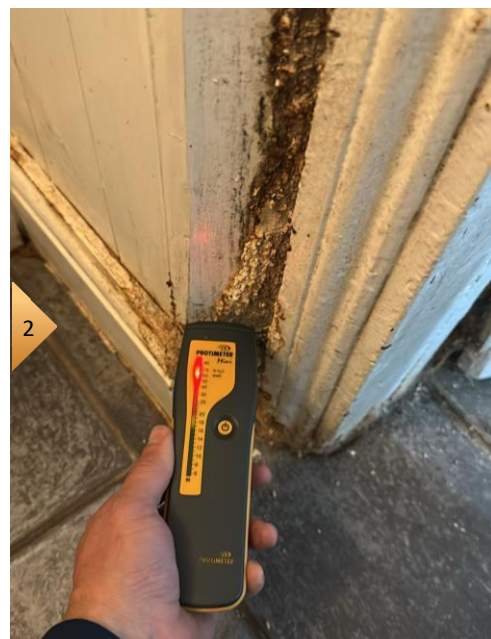
The walls to the hallway have been clad in tongue and groove boarding. There is widespread evidence of dampness to the timbers and, by extension, to the walls behind. The timbers are completely saturated to maximum levels and there is evidence of wet rot to the door casings and skirting boards, complete with fruiting bodies.

1. Wet rot and saturated timbers at low level
2. Wet rot and saturated timbers at low level

1. The largest problem with the building is the rising and penetrating damp in the basement. To solve this issue it is recommended that the external and internal walls require plaster removing to ceiling height and a high performance damp proof membrane should be mechanically fixed to the walls. Following this treatment, it is recommended that all the walls be finished with 12.5mm plasterboard with a skimmed finish.

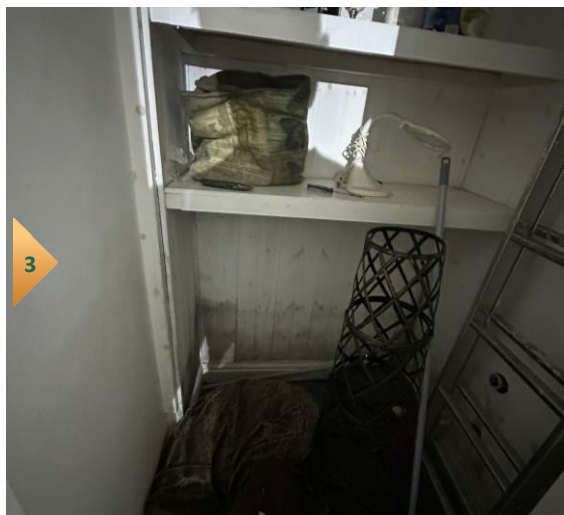
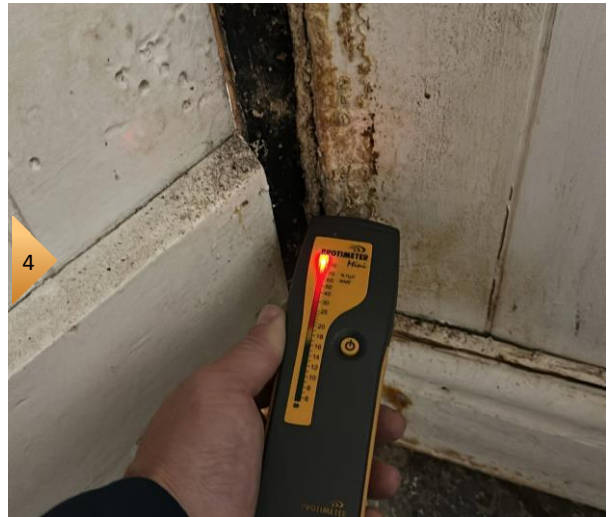
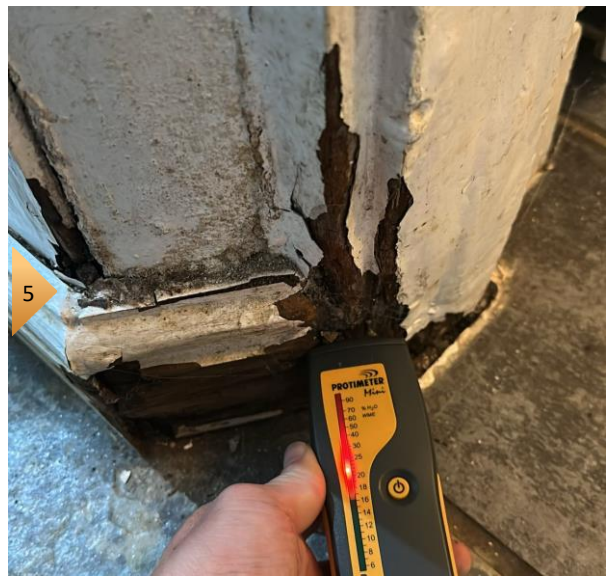
The walls to the hallway have also been clad in tongue and groove boarding. There is widespread evidence of dampness to the timbers and, by extension, to the walls behind. The timbers are completely saturated to maximum levels and there is evidence of wet rot to the door casings and skirting boards, complete with fruiting bodies.

1. General view of bathroom
2. General view of bathroom
3. Wet rot and saturated timbers at low level

4. Wet rot and saturated timbers at low level
5. Wet rot and saturated timbers at low level
6. Extractor fan

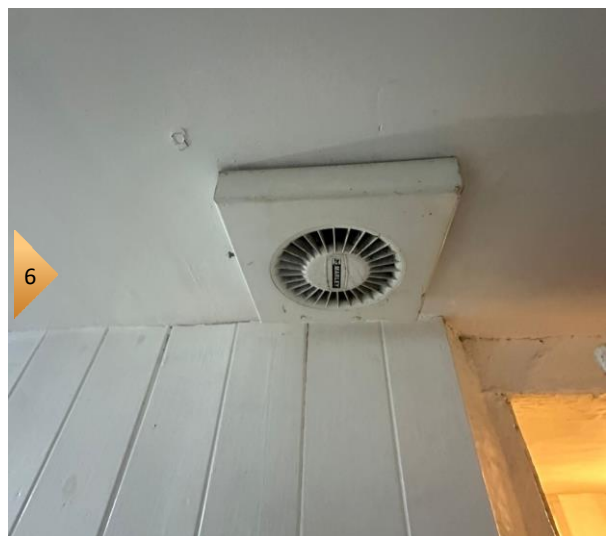
There is an extractor fan in the bathroom but it is obviously unfit for purpose. The fan discharges through ducting to the outside wall but the run is 7-8 metres long, far too long for the purpose

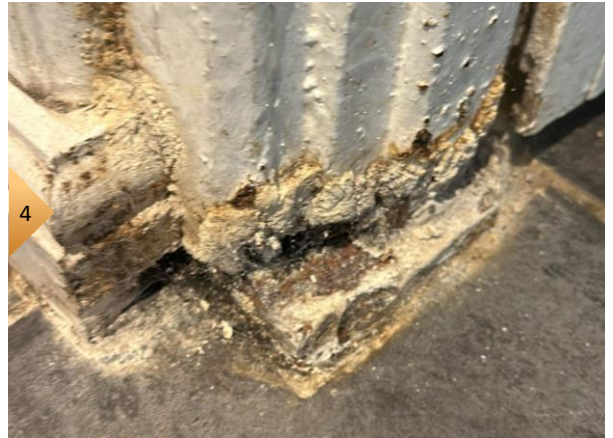
The walls to the kitchen have been studded and plasterboard and skimmed. There is widespread evidence of dampness to the plasterboard and, by extension, to the walls behind. There is evidence of wet rot to the door casings and skirting boards, complete with fruiting bodies.

4. Wet rot and saturated timbers at low level
5. Chimney breast left hand side
6. Chimney breast right hand side

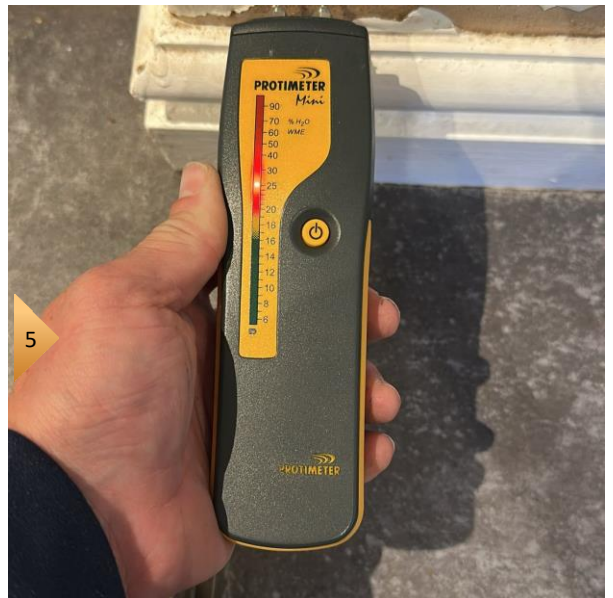
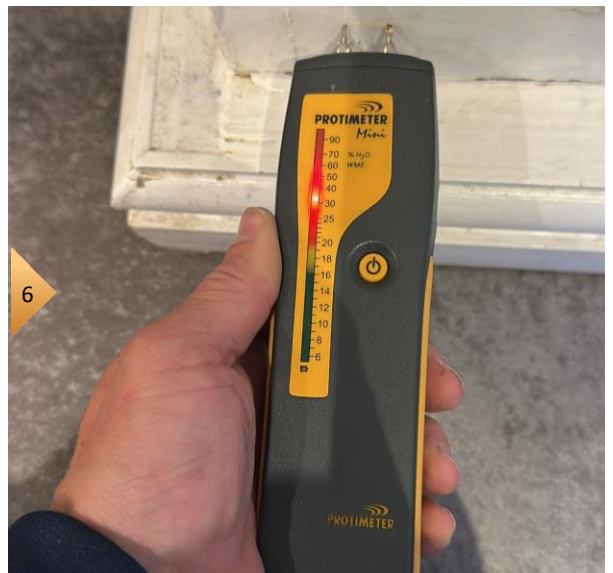
The walls to the chimney breast are plastered and are showing high reading at both sides of the opening.
