DAMP INVESTIGATION SURVEY

29 Flockton Crescent, Sheffield. S13 9QR

22 October, 2024.

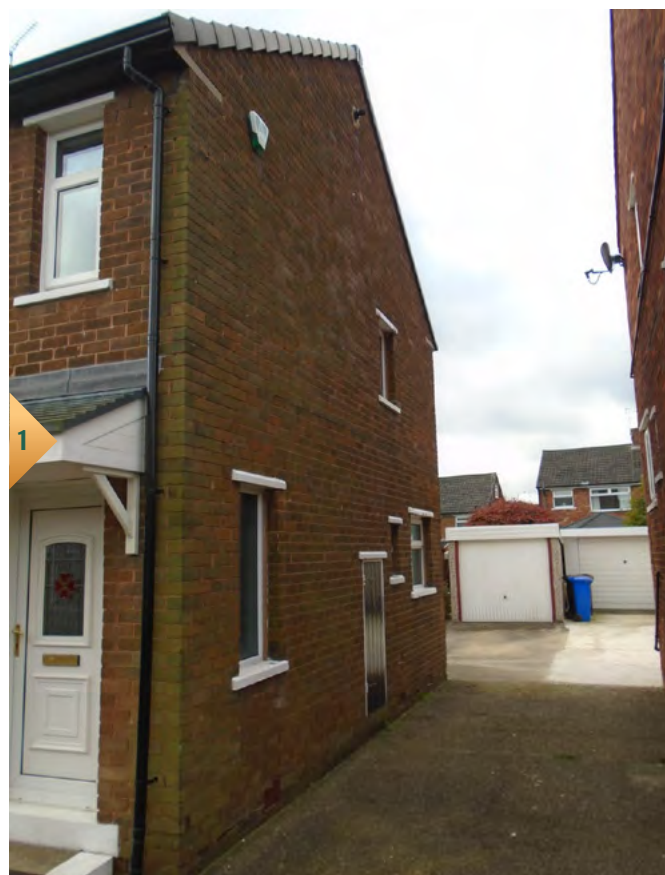
The main walls are constructed from cavity brickwork 275mm thick. The brickwork is generally in reasonable condition, although the pointing at low level has become friable and could be allowing the ingress of dampness. Normally the damp would be restricted to the external skin of brickwork but it appears that post construction cavity wall insulation has been installed which may bridge the cavity and cause internal dampness.

1. Side elevation
2. Friable pointing to lower section of elevation
3. High ground level adjacent to front elevation

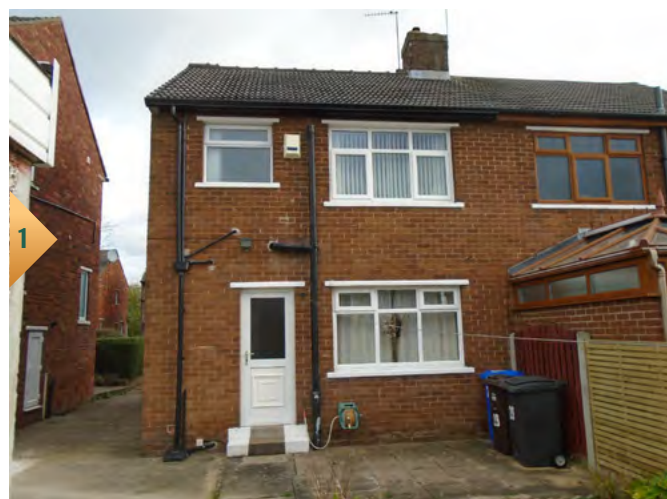
The main walls are constructed from cavity brickwork 275mm thick. The brickwork is generally in reasonable condition, although the pointing at low level has become friable and could be allowing the ingress of dampness. Normally the damp would be restricted to the external skin of brickwork but it appears that post construction cavity wall insulation has been installed which may bridge the cavity and cause internal dampness.

Within the kitchen dining area internally we did find isolated patches of dampness at very low level to the right hand side of the radiator, matching location of the stepped fracture externally, suggesting that dampness is bridging the cavity in this location.

1. Rear Elevation
2. Friable pointing to lower section of elevation
3. Friable pointing and stepped cracking to lower section of elevation

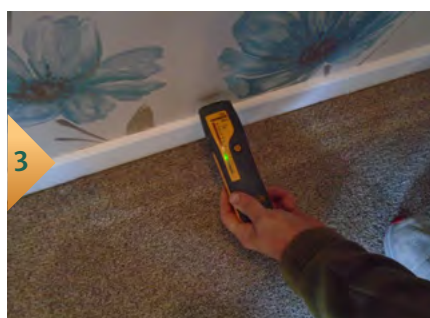
1. High meter readings at low level to wall 1 in lounge
2. High meter readings at low level to wall 1 in lounge
3. Satisfactory meter readings at low level to wall 2 in lounge
4. Satisfactory meter readings at low level to wall 3 in lounge

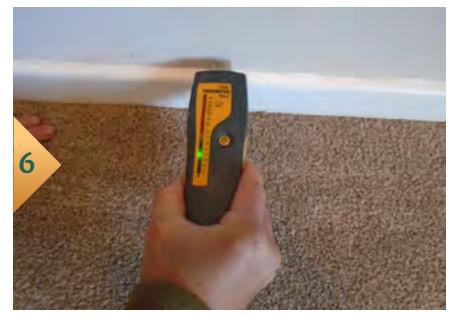
The walls within the lounge are a mixture of plaster on solid walls and plasterboard on studded wall. Generally the walls are in good condition and dry. However, there is evidence of dampness at very low level (just above the skirting board) to the external wall (wall 1). This is considered to be as a result of the friable pointing to the front elevation brickwork, allowing water to penetrate and bridge the cavity at low level.

5. High meter readings to right hand side of door to wall 4 in lounge
6. Satisfactory meter readings at low level to wall 4 in lounge

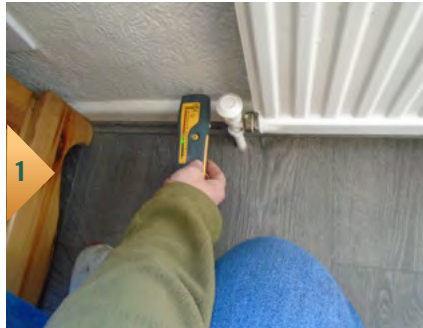
1. Satisfactory meter readings at low level to wall 1 in kitchen
2. High meter readings to right hand side of radiator to wall 1 in kitchen
3. Elevated meter readings to left hand side of external door to wall 1 in kitchen
4. Elevated meter readings to left hand side of arch to wall 3 in kitchen
5. Satisfactory meter readings to left hand side of fireplace to wall 4 in kitchen
6. Elevated meter readings to right hand side of fireplace to wall 4 in kitchen

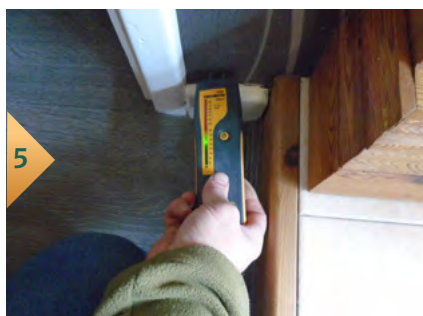
The walls within the kitchen are a mixture of plaster on solid walls and plasterboard on studded wall. Generally the walls are in good condition and dry. However, there is evidence of dampness to the external wall (wall 1) to the right hand side of the radiator. This is considered to be as a result of the friable pointing to the rear elevation brickwork and also a stepped fracture to the brickwork in this location, allowing water to penetrate and bridge the cavity. There is also evidence of elevated meter readings to the left hand side of the external door.

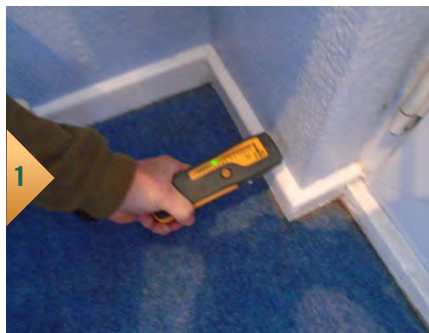
1. Satisfactory meter readings to left hand side of external door to wall 1 in hallway
2. High meter readings to left hand side of lounge door to wall 2 in hallway
