# DAMP INVESTIGATION SURVEY

5a Green Lane, Belper. DE56 1BY

25 September 2025

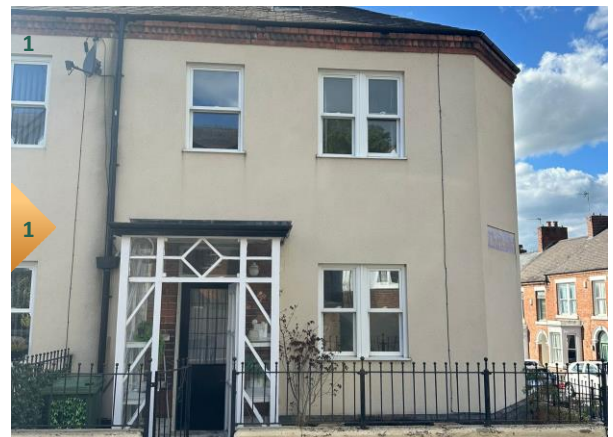
1. Front elevation
2. Undersized air brick and pressurised damp course
3. Front porch

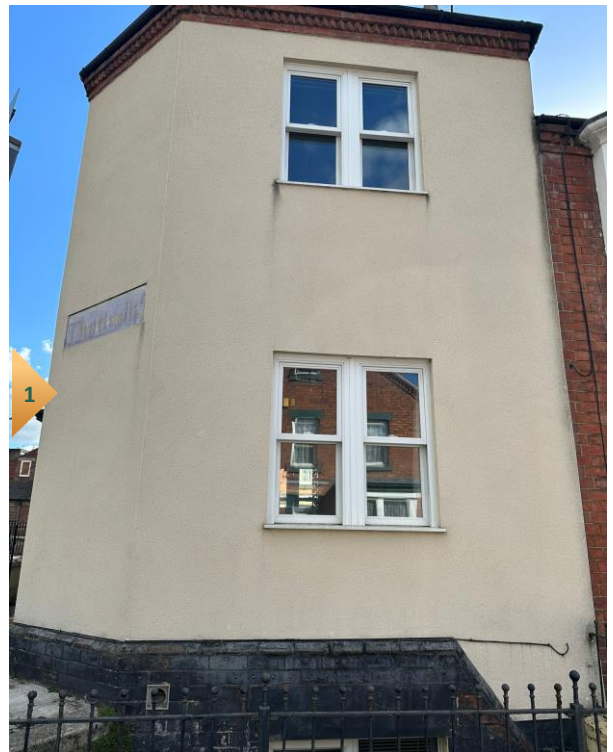
1. Right hand side elevation
2. Water staining to high level brickwork/render
3. Low level brickwork

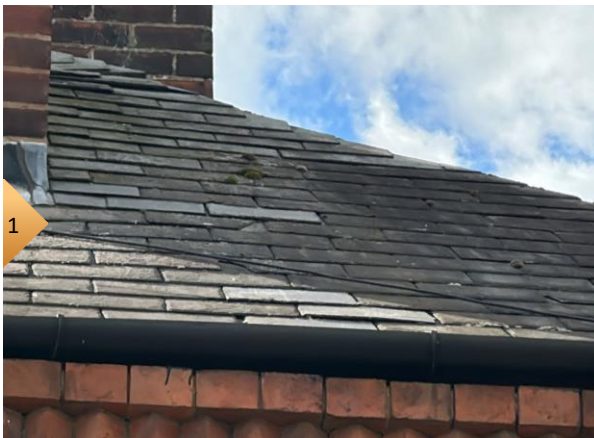
1. General view of roof
2. Flashing to chimneys
3. Gutter discharging on to neighbouring property roof
4. Water staining to render/brickwork

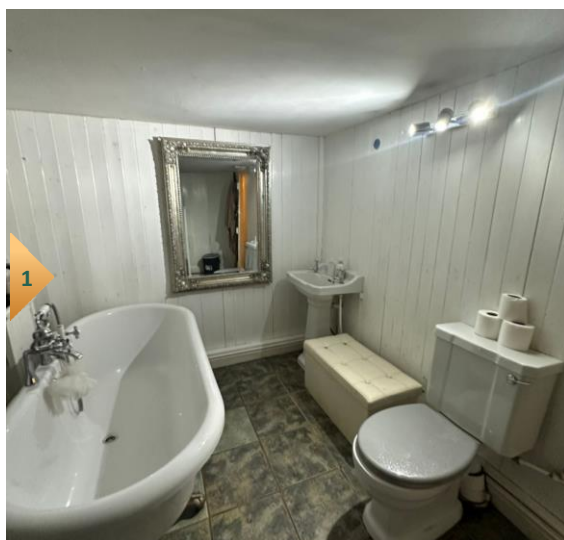
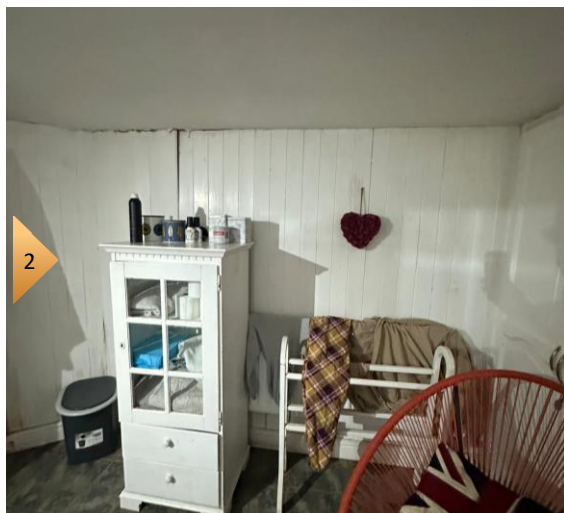
The walls to the hallway have also been clad in tongue and groove boarding. There is widespread evidence of dampness to the timbers and, by extension, to the walls behind. The timbers are completely saturated to maximum levels and there is evidence of wet rot to the door casings and skirting boards, complete with fruiting bodies.

- Meter readings were:
- Wall 1: Red
- Wall 2: Red
- Wall 3: Red
- Wall 4: Red

1. General view of bathroom
2. General view of bathroom
3. Wet rot and saturated timbers at low level

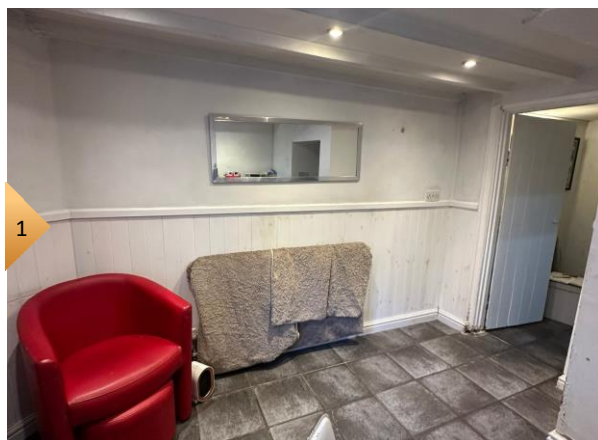
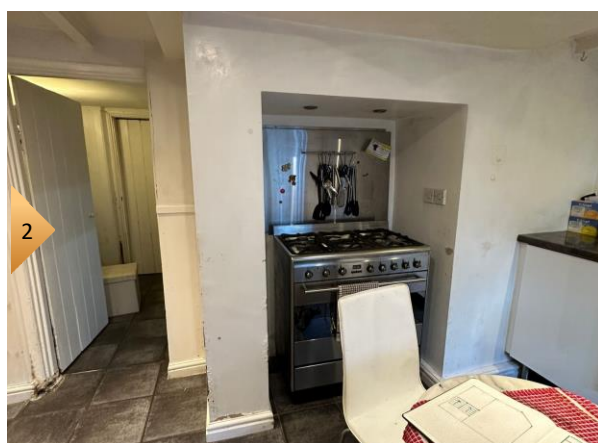
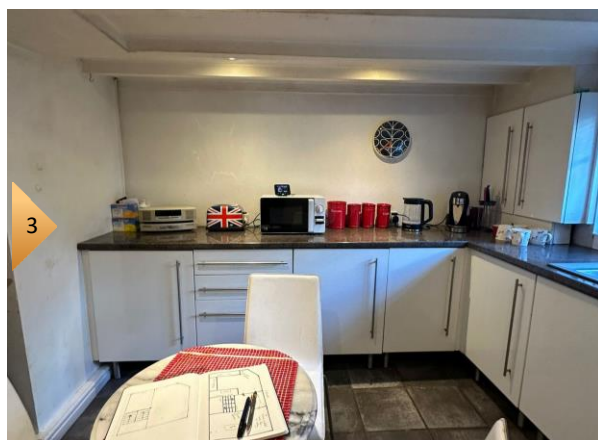
The walls to the chimney breast are plastered and are showing high reading at both sides of the opening.

- Meter readings were:
- Wall 1: No access
- Wall 2: Red
- Wall 3: Red
- Wall 4: No access

1. General view of kitchen
2. General view of kitchen
3. General view of kitchen
